Manhole Inspection Summary

Manhole # S17UU_002MH

Insp Date: **7/3/08 3:49 PM**

Location Address: **3118 REISTERSTOWN RD**

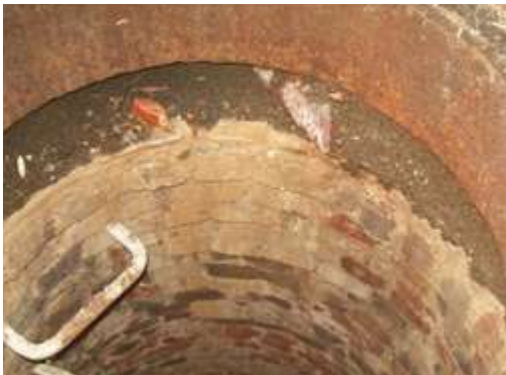
Defect 1

Condition: ☐ Sound ☐ Cracked ☐ Root Intrusion ☒ **Loose Brick** ☒ **Deteriorated**

CHIMNEY LOOSE BRICKS AND
DETERIORATION

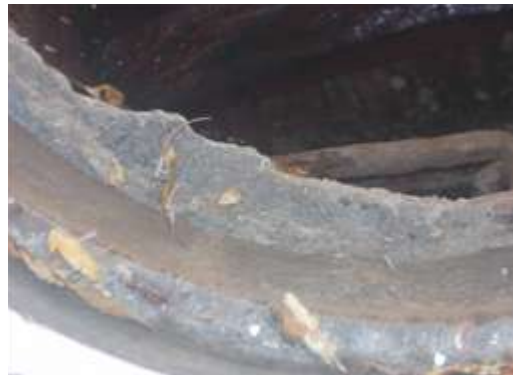
Defect 2

Offset: **2.5** (in.)

FRAME OFFSET

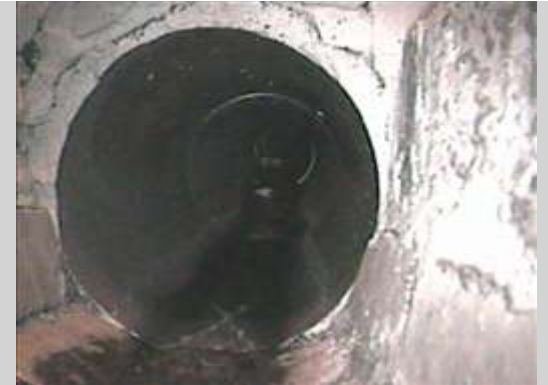
12 O'Clock Outflow

8 in. Circular Gravity Sewer
Pipe Out @ 12 O'Clock

Pipe Height: (in.) Direct
Pipe Material: **Clay** ☐ Pipe Lined
Invert Depth: **9.70** (ft.) Flow Characteristics: **Slow**
Deposits: ☒ None ☐ Mud ☐ Sludge ☐ Debris ☐ Grease
Silt Depth: (in.) Deposits Extent:
Infiltration: **None** Pipe Seal Cond: **Sound**

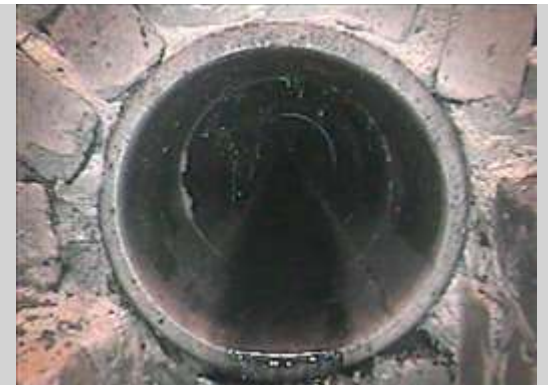
3 O'Clock Inflow

8 in. Circular Gravity Sewer
Pipe In @ 3 O'Clock

Pipe Height: (in.) Direct
Pipe Material: **Clay** ☐ Pipe Lined
Invert Depth: **9.00** (ft.) Flow Characteristics: **Slow**
Deposits: ☒ None ☐ Mud ☐ Sludge ☐ Debris ☐ Grease
Silt Depth: (in.) Deposits Extent:
Infiltration: **None** Pipe Seal Cond: **Sound**

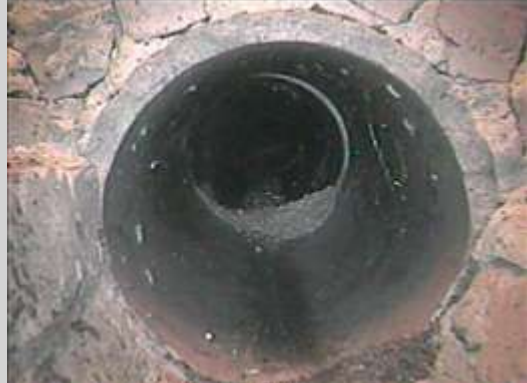
6 O'Clock Inflow

8 in. Circular Gravity Sewer

Pipe In @ 6 O'Clock

Infiltration: **None** Pipe Seal Cond: **Sound**
